**ANALYTICAL AND EXPERIMENTAL
INVESTIGATION OF AIRCRAFT
METAL STRUCTURES REINFORCED
WITH FILAMENTARY COMPOSITES**

Phase II - Structural Fatigue, Thermal Cycling,
Creep, and Residual Strength

by B. Blichfeldt and J. E. McCarty

Prepared by
THE BOEING COMPANY
Seattle, Wash. 98124
for Langley Research Center

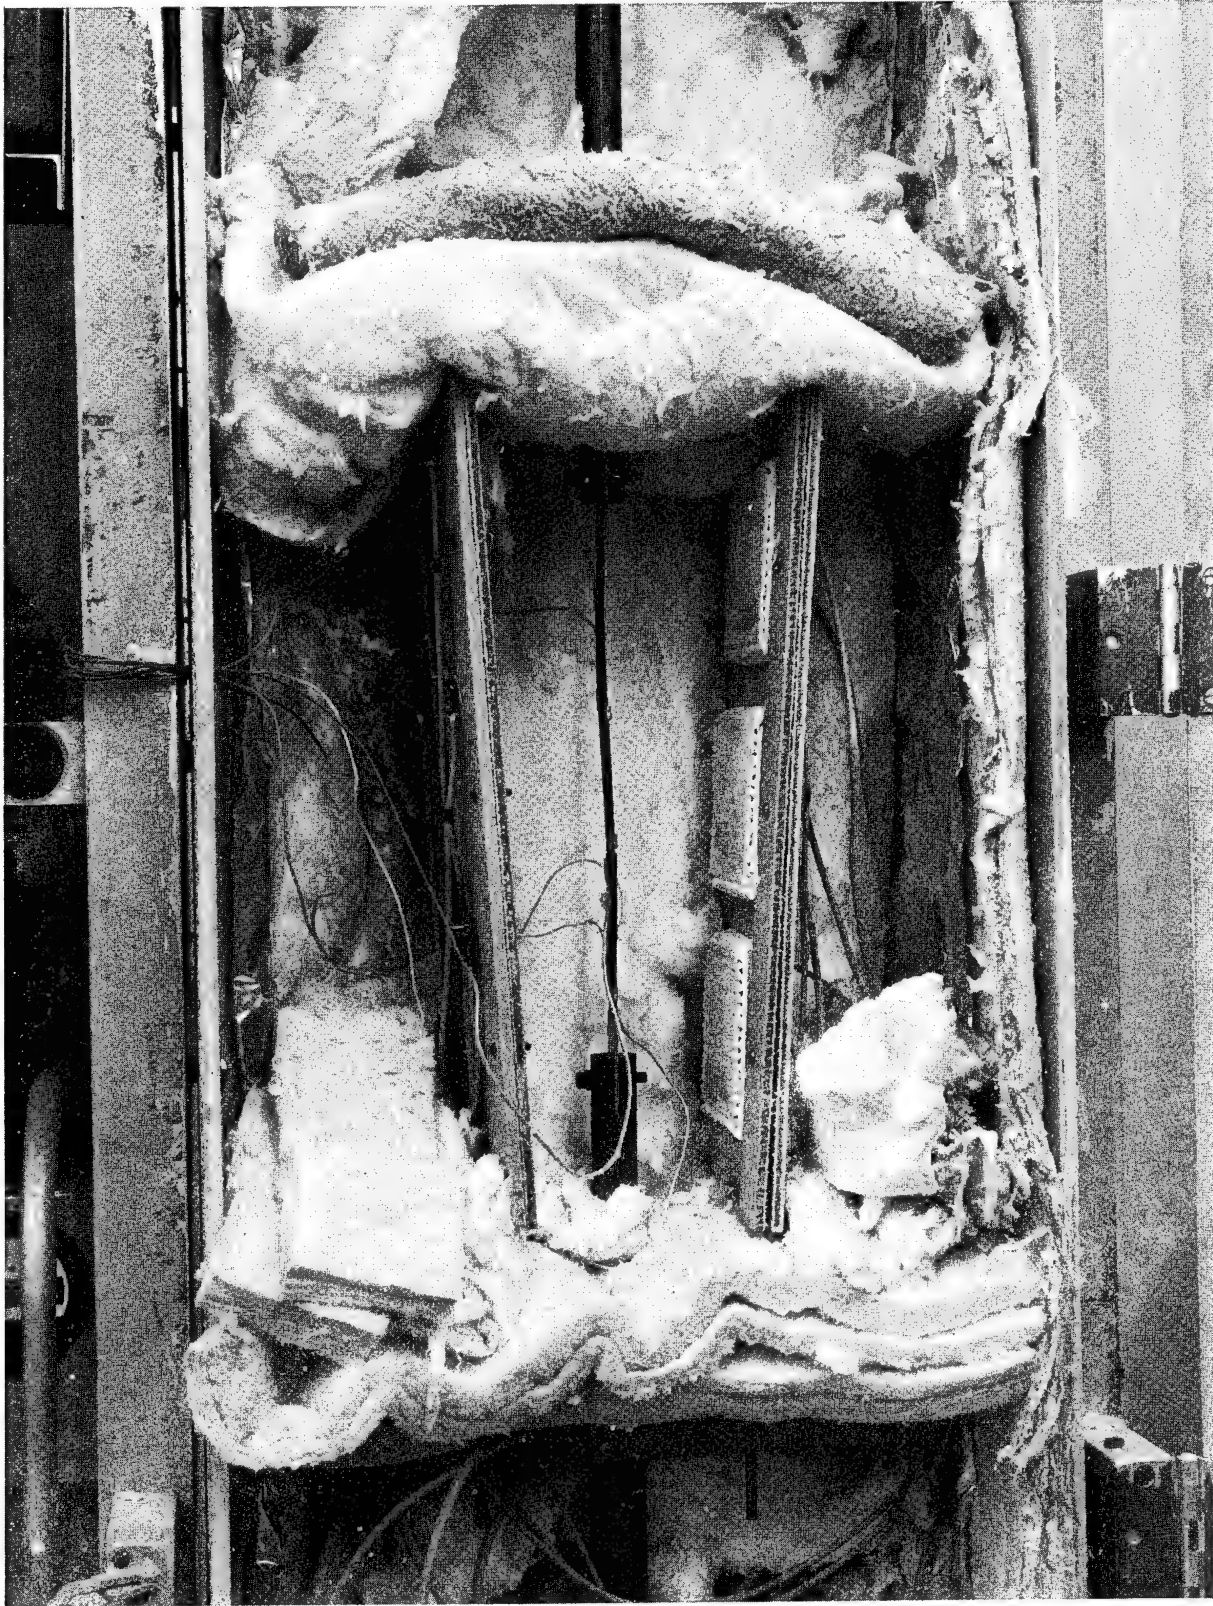
FIGURE 22.—CREEP AND RUPTURE TEST SETUP

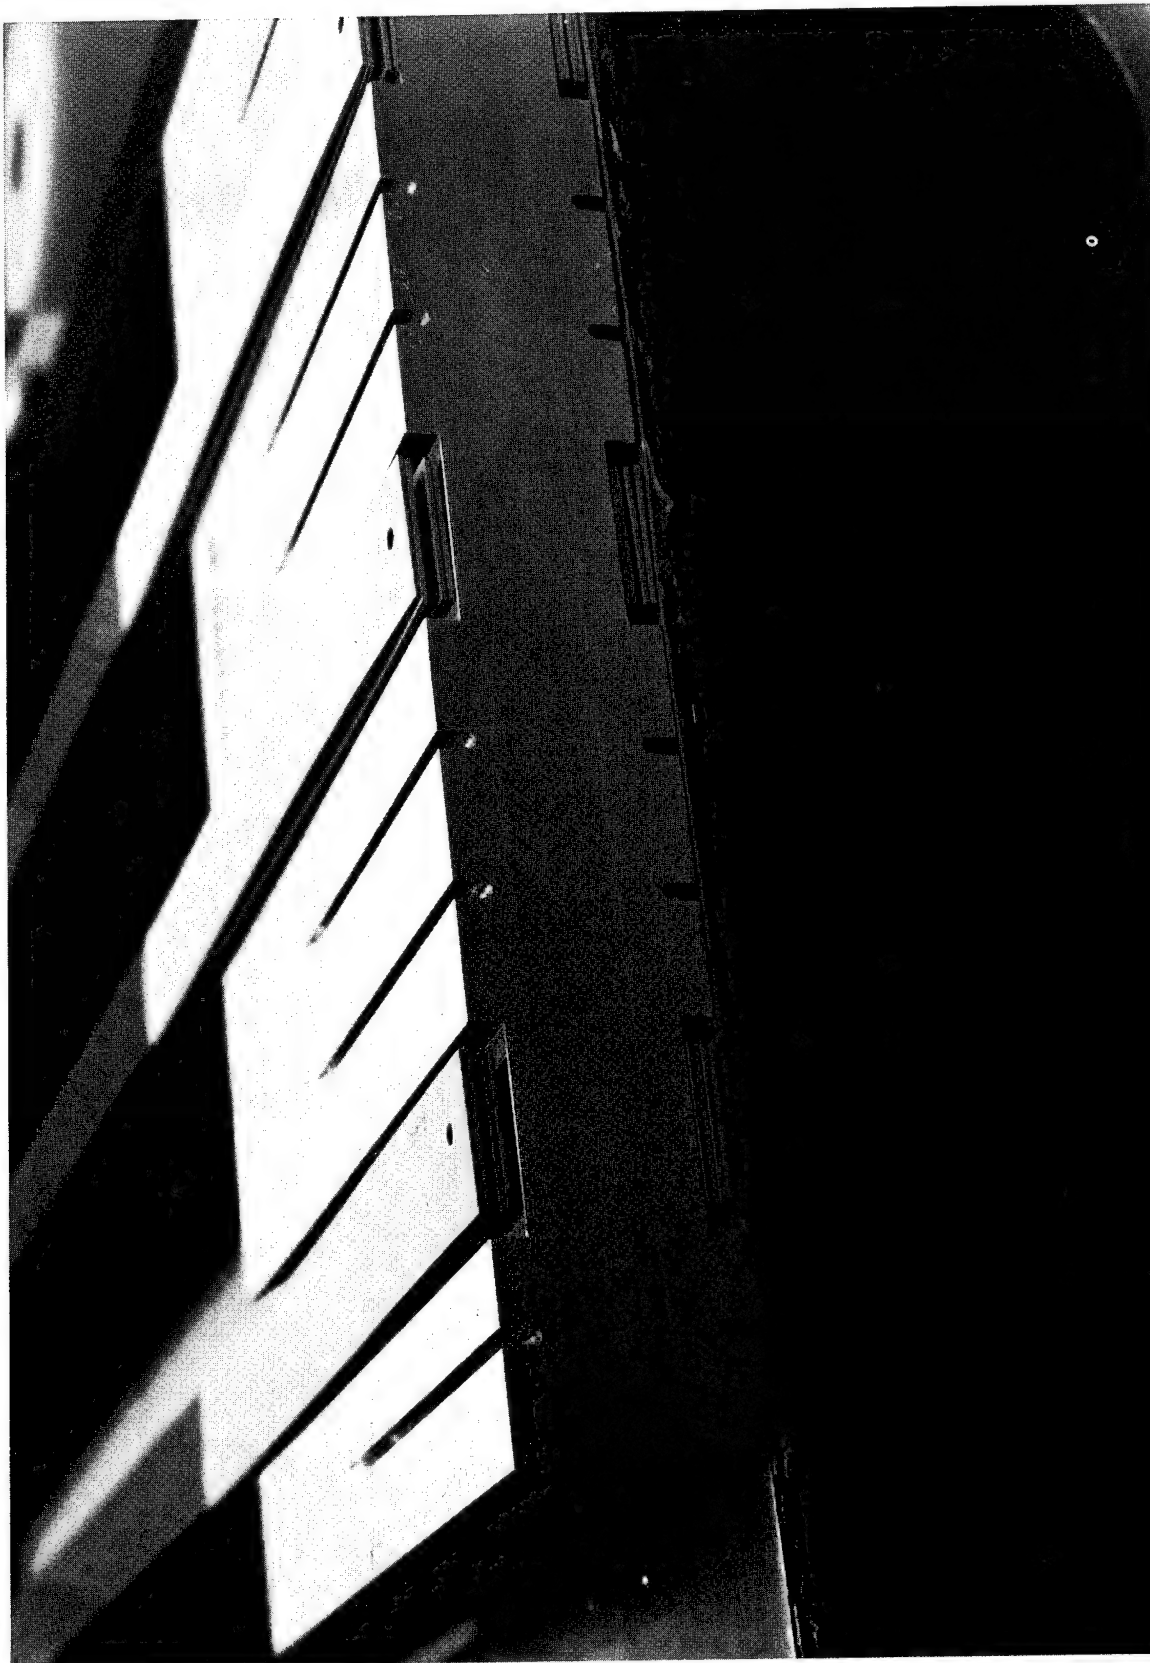
FIGURE 29.—DETAIL OF GRIP PLATE FOR CONCEPT 2c

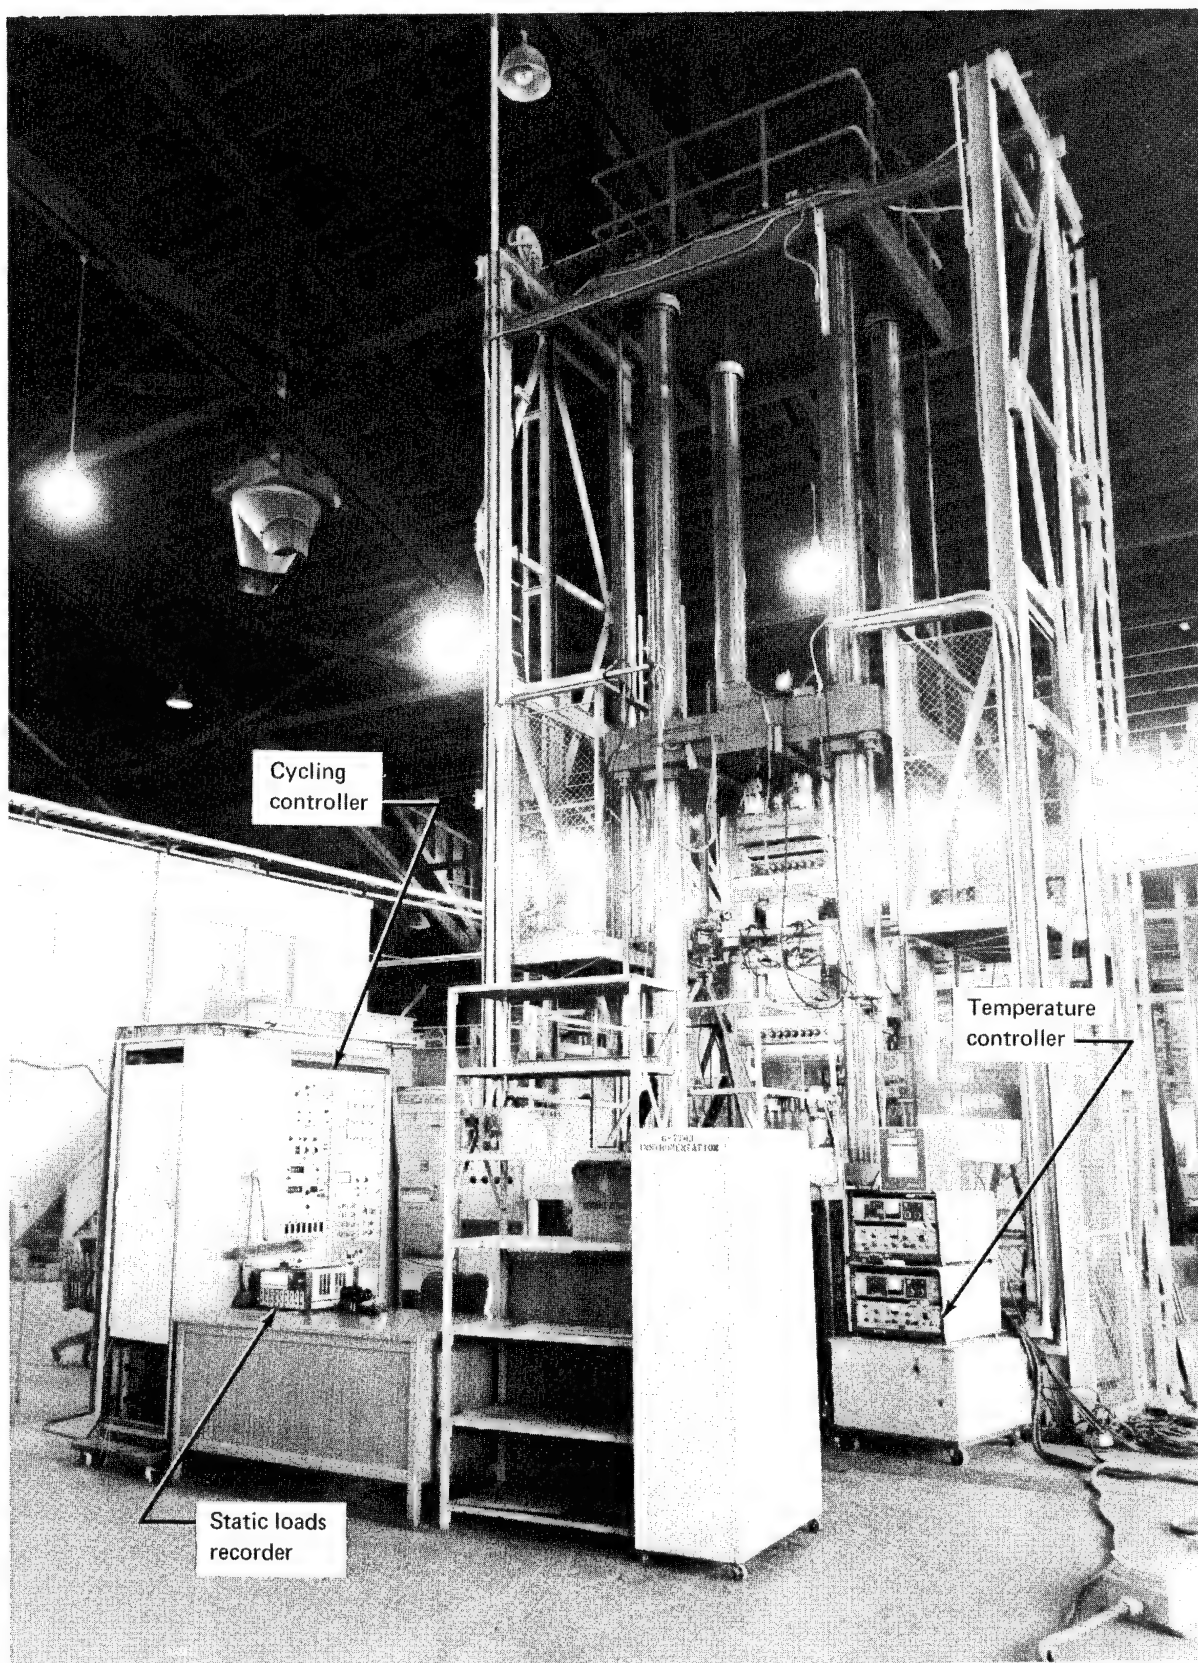
FIGURE 32.— 150-KIP ELECTROMECHANICAL RESEARCH FATIGUE MACHINE
